DEPARTMENT OF TRANSPORTATION**DIVISION OF ENGINEERING SERVICES**

Contract #: 04-0120F4Cty: SF/ALA Rte: 80 PM: 13.2/13.9File #: 69.28**WELDING INSPECTION REPORT****Resident Engineer:**Pursell, Gary**Address:** 333 Burma Road**City:** Oakland, CA 94607**Report No:** WIR-001237**Date Inspected:** 09-Nov-2007**Project Name:** SAS Superstructure**OSM Arrival Time:** 630**Prime Contractor:** American Bridge/Fluor Enterprises, a JV**OSM Departure Time:** 1530**Contractor:** Zhenhua Port Machinery Company, Ltd (ZPMC), Changxing Island **Location:** Shanghai, China**CWI Name:** Fu Yu Hong**CWI Present:** Yes No**Inspected CWI report:** Yes No N/A**Rod Oven in Use:** Yes No N/A**Electrode to specification:** Yes No N/A**Weld Procedures Followed:** Yes No N/A**Qualified Welders:** Yes No N/A**Verified Joint Fit-up:** Yes No N/A**Approved Drawings:** Yes No N/A**Approved WPS:** Yes No N/A**Delayed / Cancelled:** Yes No N/A**Bridge No:** 34-0006**Component:** OBG**Summary of Items Observed:**

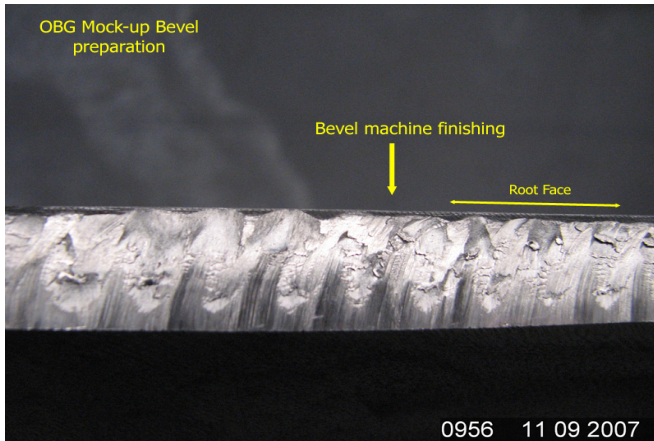
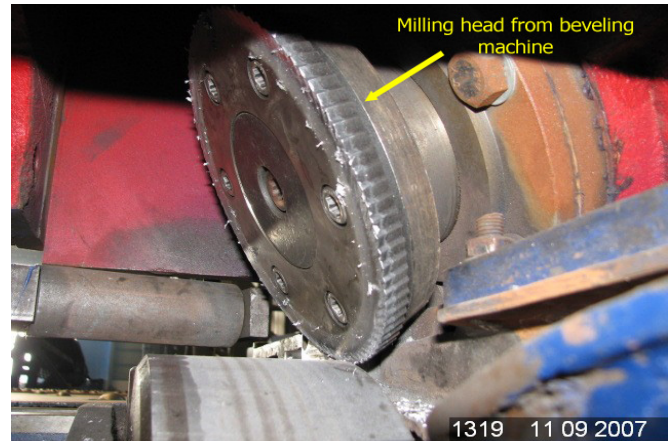
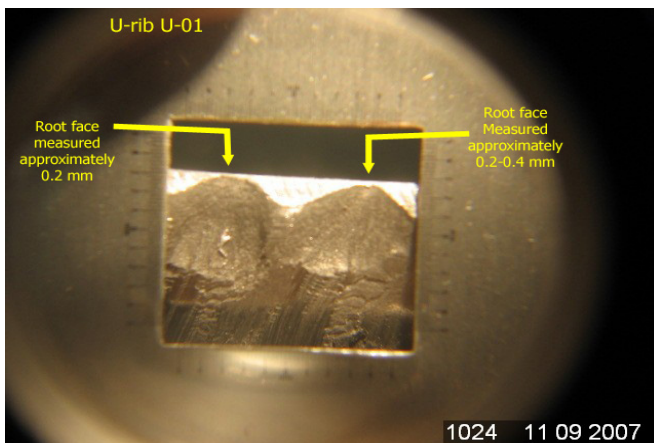
Item Description	WBS	Dwg No.	Status
1 Visual and Dimensional verifications of the Bevel Angles and Root Faces OBG Deck Mock-up			
The QA inspector performed visual and dimensional verifications for the bevel angles and the root faces for the Deck Mock-up (10 ribs, 5 ribs with approximately 13158 mm of length designated as U-01 through U-05 and 5 ribs with approximately 1750 mm of length designated as U-06 through U-10). The QA inspector found that bevel angles and root faces appeared to be in compliance with the contract documents however the QA inspector found that the roof faces had localized areas where the mill machine removed material resulting in root faces with less than 1 mm. The QA inspector representative informed Caltrans representative Chengwen Liu about the issue. The visual inspection of the root faces was still in process at the end of shift. ZPMC, ABF and Caltrans were aware of the issue and were discussing about the finishing of the root faces for OBG Deck Mock-up U-ribs bevel preparation and localized areas with less than 1 mm of root faces. See photographs below.

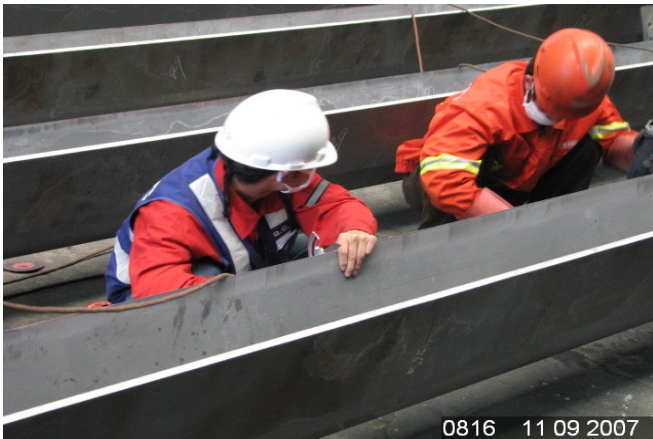
- 2 ZPMC bevel angle and root faces verifications on the OBG Deck Mock-up
- The QA inspector observed ZPMC performing bevel angle and root faces dimensional verifications.
